**WORLD WAR II GERMAN  
FIRE DOCUMENT TRANSLATIONS**

## **WORLD WAR II GERMAN FIRE DOCUMENT TRANSLATIONS**

By: Carl F. Miller

REPORT OF THE REGIMENTAL COMMANDER OF THE FIRE-PROTECTION POLICE REGIMENT "SAXONY" ABOUT THE COURSE AND RESULTS OF THE MASSIVE AERIAL ATTACKS ON ROTTERDAM ON MAY 14, 1940, AND THE EXPERIENCES DRAWN THEREFROM (by Hans Rumpf) . . . . .	A-1
The Air Defense Fire Service . . . . .	A-1
The German Action to Occupy Rotterdam and the Aerial Attack of May 14 . . . . .	A-2
The Consequences . . . . .	A-3
The Organization of the Rotterdam Fire Department . . . . .	A-12
Efforts of the Voluntary Fire Department of Rotterdam After the Great Aerial Attack of May 14 . . . . .	A-21
Losses of the Rotterdam Fire Department . . . . .	A-24
Eyewitness Accounts . . . . .	A-25
Comments on the Foregoing Eyewitness Accounts . . . . .	A-40
The Renewed Superiority of Effects of Fire . . . . .	A-44
Additional Observations . . . . .	A-55
Appendix (to Rumpf's Report) . . . . .	A-71

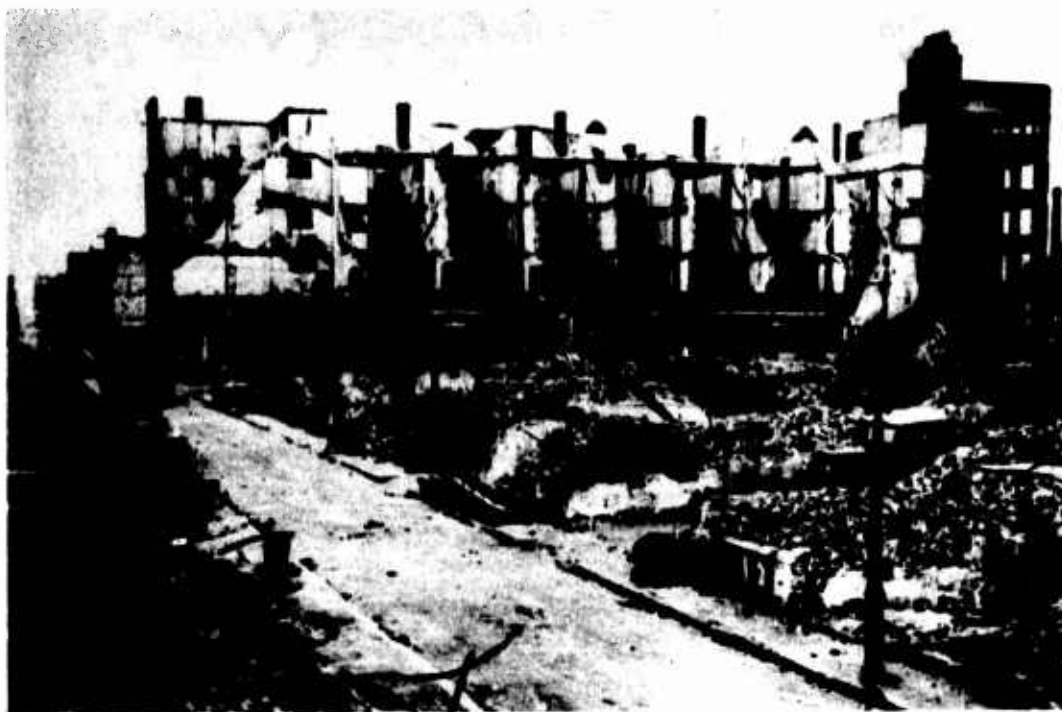
high explosive bomb, which destroys a city mansion in one hit (see Pictures 57 and 58).

Pictures 57, 58 BLAST-DAMAGED MANSIONS AND APARTMENTS

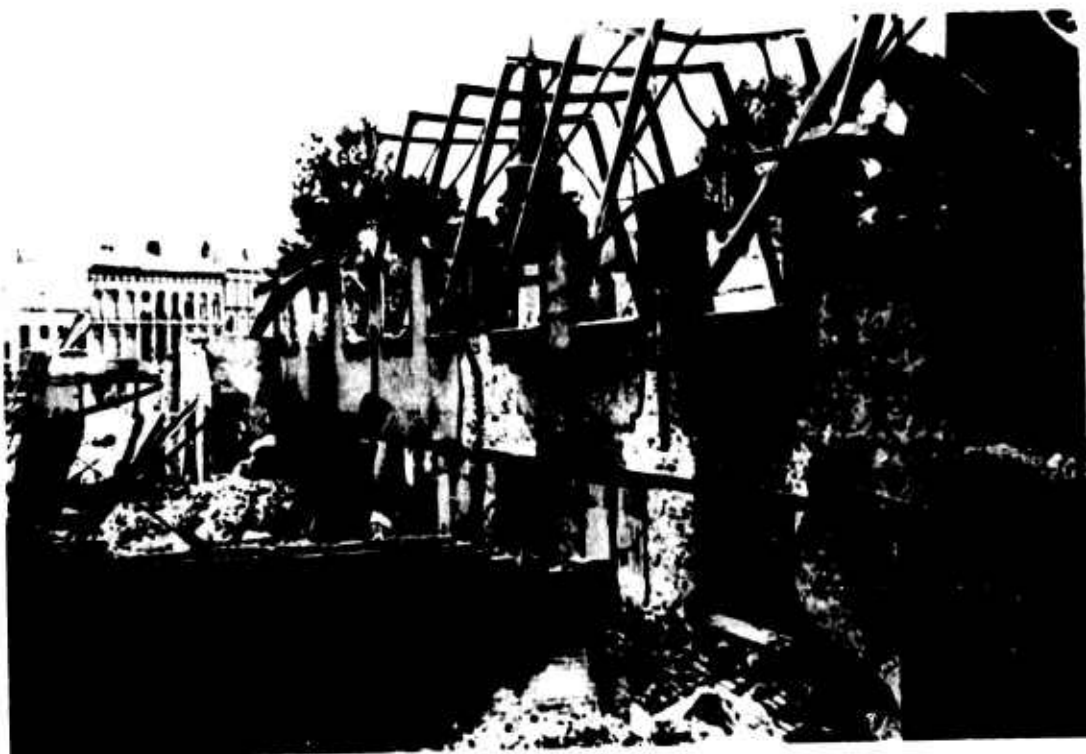
**Picture 76 FIRE-DESTROYED ROOF OF NIGHTCLUB IN COOLSINGEL DISTRICT**
